The Archaeological Site of Konar Sandal, Jiroft, Iran: Conservation of Earthen Architecture

Manijeh Hadian Dehkordi, Rasool Vatandoust, Youssef Madjidzadeh, and Mohsen G. Kashi

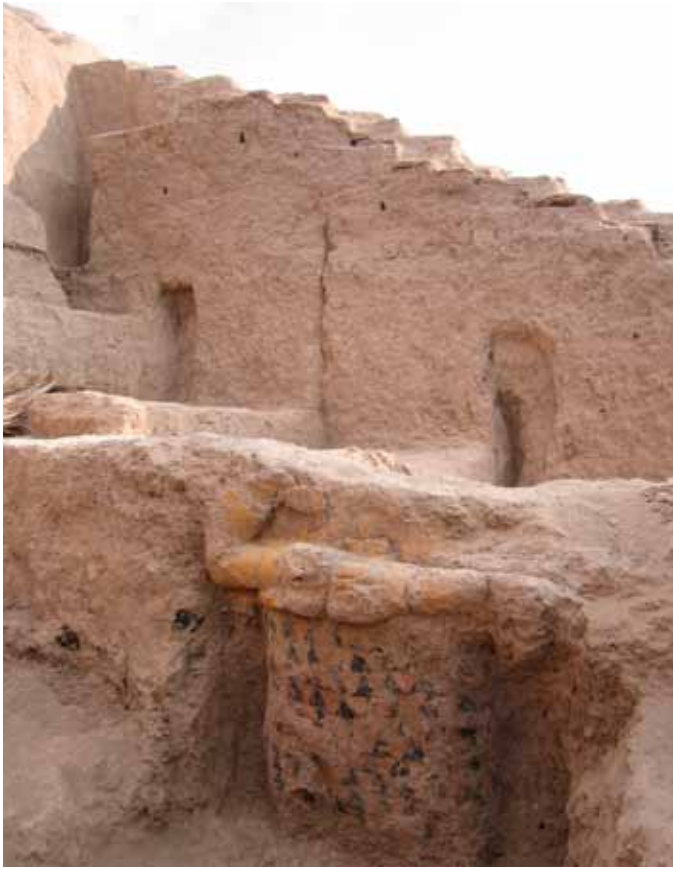
FIGURE 1 Northern main hill of Konar Sandal. Photo: Nader Soleimani, Archaeological Research Base, Halil Rood region

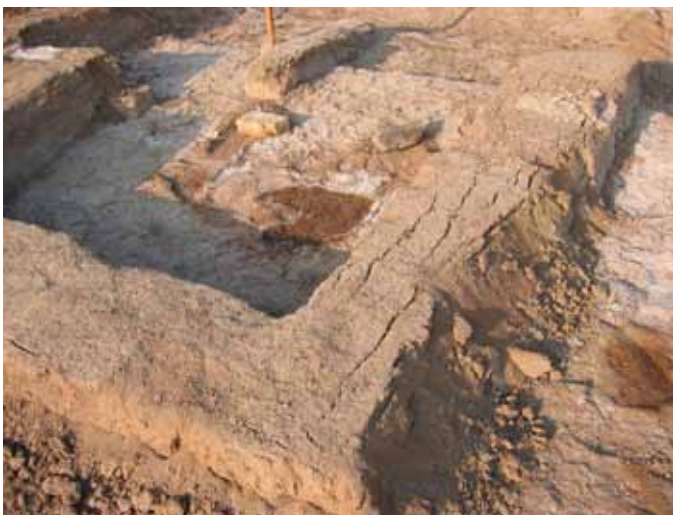
Some of the damage to the structures may have occurred in the interim period between the two seasons of excavations and even during excavation when the walls were not adequately protected. Factors contributing to the rapid erosion of exposed adobe walls are the local soil's extraordinary ability to absorb

FIGURE 2 Rapid erosion of exposed adobe. Photo: Manijeh Hadian, RCCCR

water (hygroscopicity), extensive water runoff that has caused soil erosion and the formation of deep furrows and water conduits, and the efflorescence and dissolution of soluble salts on and just below the wall surfaces (fig. 2).

Our studies indicate that the erosion of adobe structures is partially attributed to montmorillonite minerals and chlorine and sodium sulfate salts in the soil. These expandable clays and soluble salts accelerate disintegration of the adobe, especially at the wall tops and bases, which are exposed to rain and high groundwater levels respectively. In dry weather a high degree of surface evaporation transports soluble salts through the earthen wall, leaving efflorescences on and just below the adobe surface.

- Insulate the structures against moisture and temperature fluctuations and reduce surface evaporation by protecting the exposed surfaces with materials such as geotextiles, soil, mud brick, and adobe plaster.
- Regrade the site to eliminate standing water and divert surface water runoff.
- Reduce groundwater levels by drilling wells in the vicinity of the site (this method requires detailed geological studies).

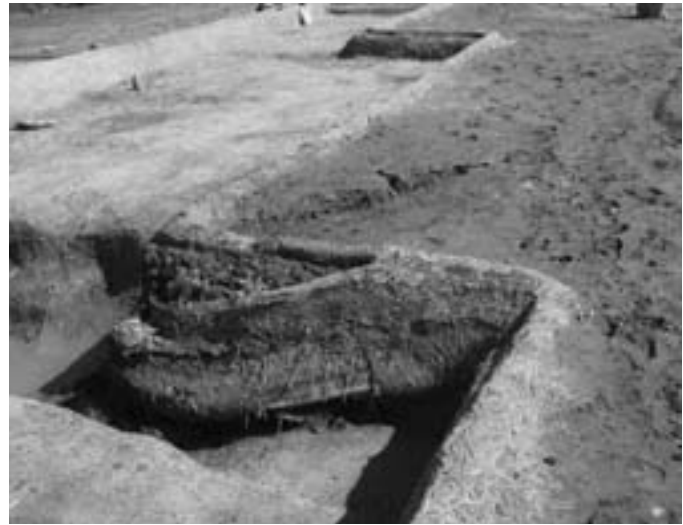
FIGURE 3 The use of adobe plaster on jute textile. Photo: Manijeh Hadian, RCCCR

In the first and second seasons of excavation, archaeologists experimented with various methods to protect the architecture found in multiple layers. These methods included covering the walls with adobe plaster on jute textile (fig. 3), constructing new brick walls covered with adobe plaster to protect the original fabric, and applying temporary plastic sheathing over the exposed areas (figs. 4, 5). Each of these methods suffered certain shortcomings and disadvantages that made them incapable of fully preventing damage to the structures. A critical problem was insufficient adhesion between the new and old materials, a lack of adequate protective covering, and high moisture permeability in the old walls.

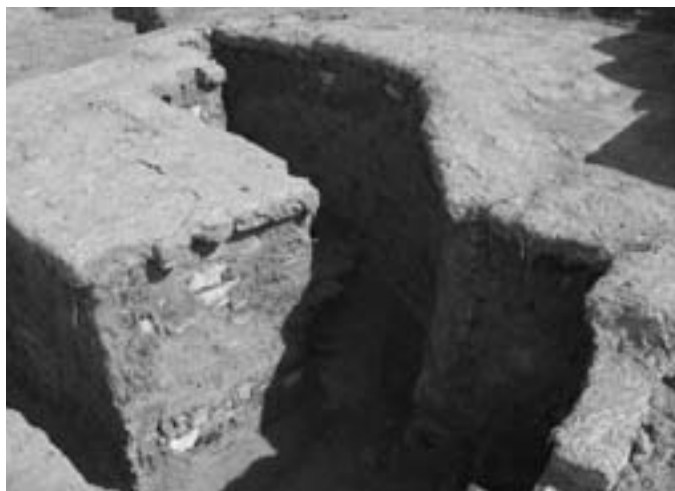
FIGURE 4 The raising of brick walls covered with adobe plaster as a means of protecting the main walls. Photo: Manijeh Hadian, RCCCR

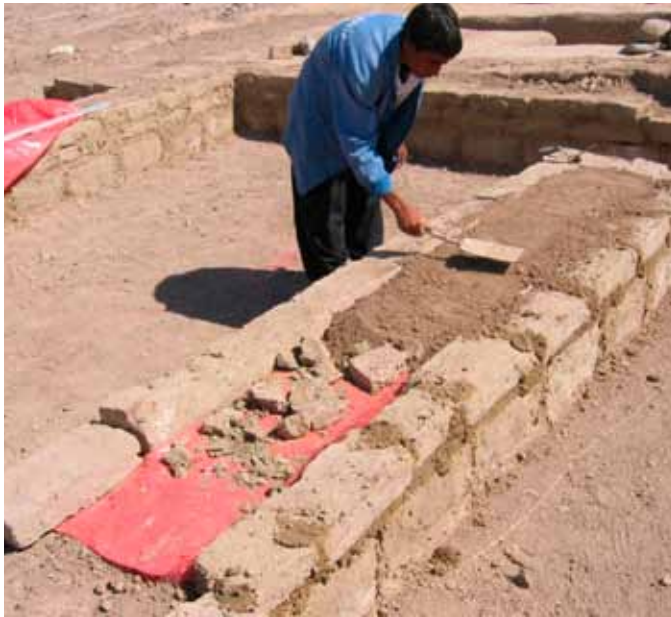
FIGURE 6 The conservation method of treating the walls within the trenches. Photo: Manijeh Hadian, RCCCC

Conservation of the walls within the trenches began with new mud bricks set in mud mortar laid approximately 5 centimeters from the original wall. The space between the new and the original walls was filled with compressed earth (fig. 6). It should be noted that the soft nature of the adobe bricks enables the mason to cut them to the required dimensions as the work proceeds. The tops of the walls were covered with a layer of geotextile and a layer of compressed earth 10 centimeters thick, followed by another layer of mud bricks and compressed earth. This was covered with adobe plaster sloped at an incline to shed water.

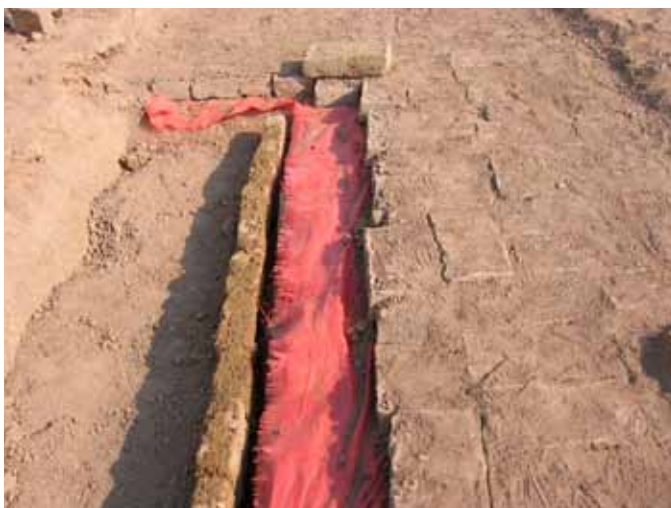
FIGURE 7 The conservation method of treating the brick floors. Photo: Manijeh Hadian, RCCCC

The same materials and methods were used to protect the brick floors (fig. 7). First, the surface of the floors was leveled using compressed earth. This was covered with a layer of geotextile and an additional layer of bricks. A thin layer of soil was used

to fill the gaps and create the required slope for the adobe plaster. One-centimeter-diameter holes were pierced through the geotextile material to allow airflow and reduce condensation.
